## Four-Point Play on Texas Tank

For a 1-million-gallon (3,785.4 m<sup>3</sup>) elevated water tank in Austin, Texas, which was built in the '80s, the steel surface was in good shape, but it was time for maintenance.

Coat and line a 1-million-gallon (3,785.4 m<sup>3</sup>) elevated water tank

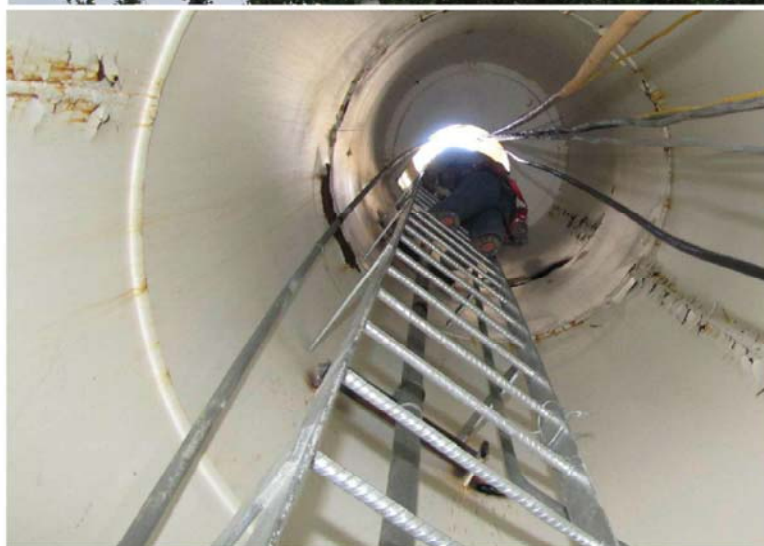
Create a containment, line the interior, and coat the exterior. A 10-person crew from Blastco, a TF Warren Company out of the Houston area, was up to the task.

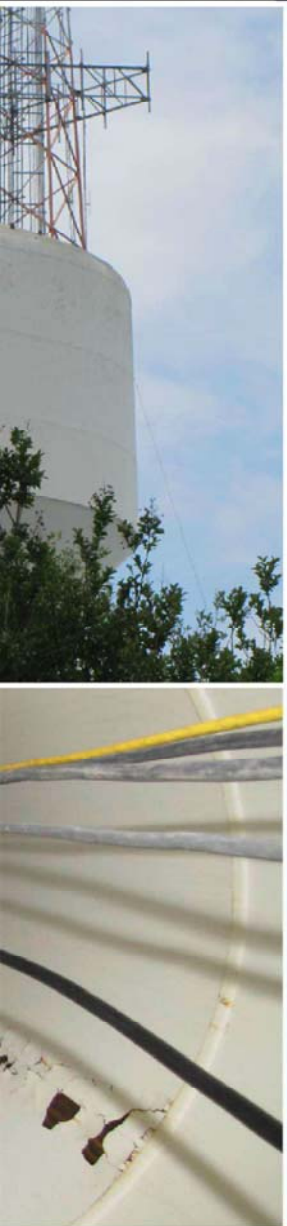
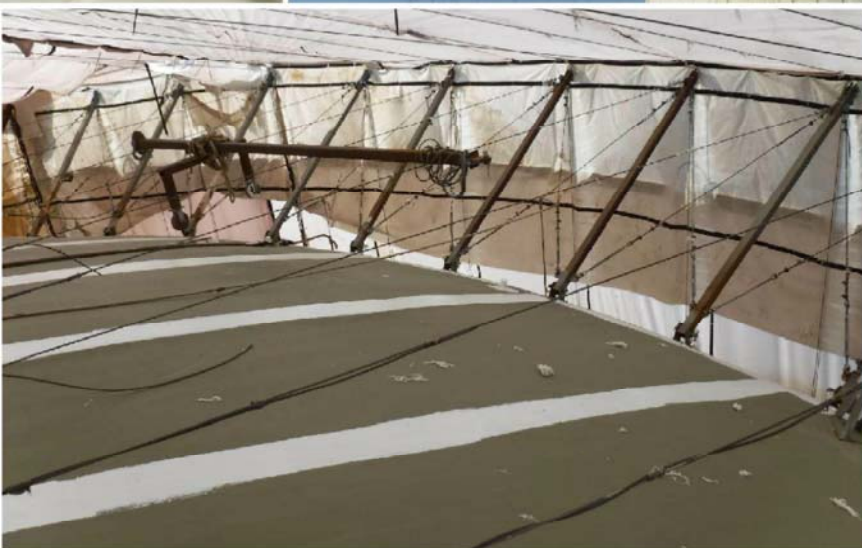
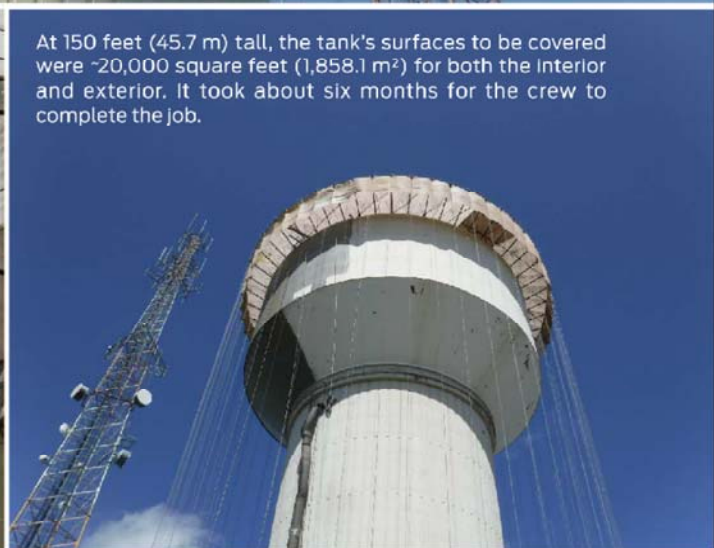
At 150 feet (45.7 m) tall, the tank's surfaces to be covered were ~20,000 square feet (1,858.1 m<sup>2</sup>) for both the interior and exterior. It took about six months for the crew to complete the job.

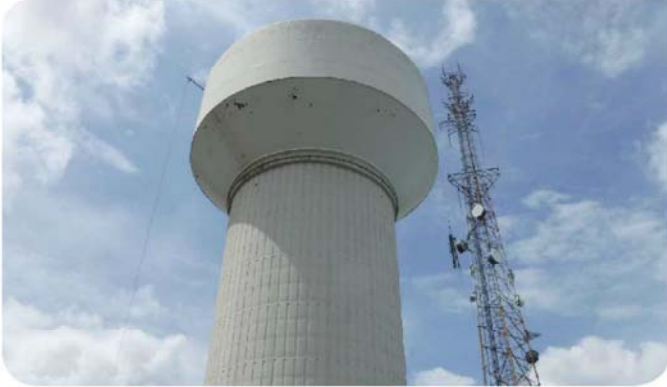
The project started on the tank's interior. But when they were only about halfway done with the work inside, they headed back outside to prep and prime a trough that had been left off the drawings.

In between the tank's pedestal and shell was a trough that ran around the exterior. According to Winter, the trough caused trouble for maintenance crews, and the city wanted to cover the exposed area so that the crews wouldn't have to worry about cleaning it out. It would have been fairly straightforward except that the work drawings were missing that item.

"No one realized it until we were about halfway done with the inside," Winter said. A city worker eventually mentioned it before too long, but between figuring out the fee, subbing out the welding work, and blasting and painting the 18-inch (45.7 cm) panel, it cost the crew seven weeks.

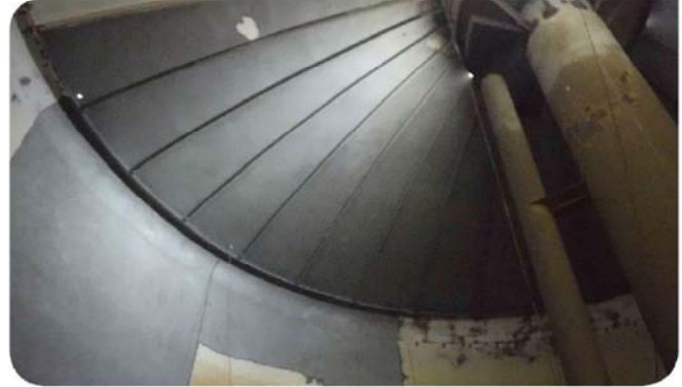
On the inside, surface prep included the use of AMASTEEL to achieve a NACE No. 2/Society for Protective Coatings (SSPC) Surface Preparation (SP) 10: Near-White Blast Cleaning, as well as dehumidifiers.

The crew worked to blast the approximately 20,000 square feet (1,858.1 m<sup>2</sup>) to achieve a NACE No. 2/Society for Protective Coatings (SSPC) Surface Preparation (SP) 10: Near-White Blast Cleaning. They sprayed out the entire interior of the tank in about 9 days, and they kept most of the blast with the use of a dehumidifier from Dehumidification Technologies before

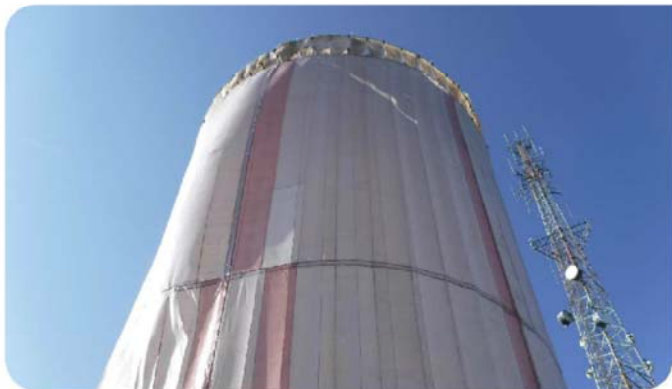
It took four weeks to install the containment, which used panels from Eagle Industries. Each day, it was winched up at the start and dropped back down at the end of the day.

It took the crew four weeks to install the containment, drilling ground anchors every 4 feet (1.2 m). And it took about a week at the end of the job to drop it for good. "It comes down way easier than it goes up," Winter said. And since there were no heavy winds or any other issues that might damage the materials, they were able to recycle the containment for another tank not too far away.

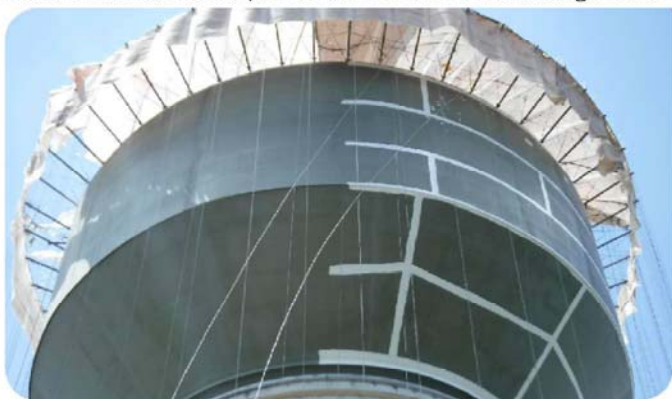
Using stages, the crew applied a ~3-mil (76.2 microns) coat of Interzinc 52 using Graco plural component equipment. That layer was then sanded and stripe coated with Interfine 1080 using rollers.

Working from two 20-foot-long (6.1 m) stages rented from BETCO, the crew worked in vertical sections. "We were getting a couple of drops a day, meaning up and down twice on that particular run," Winter explained. First, they spray applied Interzinc 52 to an average of 3 mils (76.2 microns) with Graco 33/1 ratio airless sprayers. Then they sanded the green primer

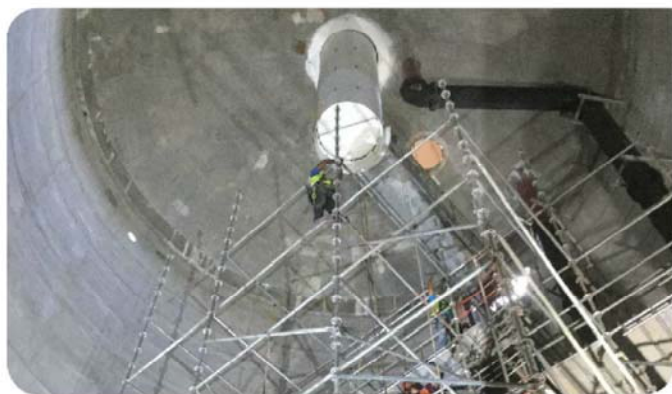
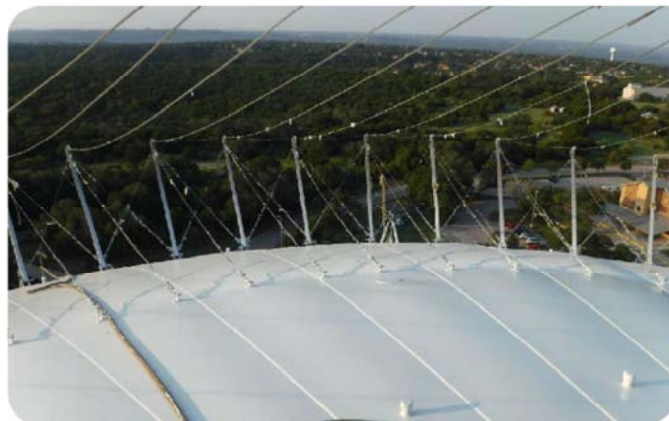
Wearing Tyvek suits, safety glasses, and rubber gloves, the crew spray applied the systems outside and inside. The lining was a 30-mil (762.0 microns) layer of International Paint Polibrid 705E.

The heat in Texas can be brutal, so it was important on this and every other project in the area to pay attention to safety. The crew took hourly water breaks and shifted start times.

As with the other interior portions, two crew members spray applied the lining: International Paint Polibrid 705E. They used Graco plural component equipment with 20-foot (6.1 m) hoses attached to shipping containers mounted outside the tank. The Polibrid 705E is a solvent-free elastomeric urethane, and it was applied to an average thickness of 30 mils (762.0 microns) in one pass. Although the crew checked it with a wet film thickness gage that day, Winter assured that the dry film thickness (DFT) is chief.

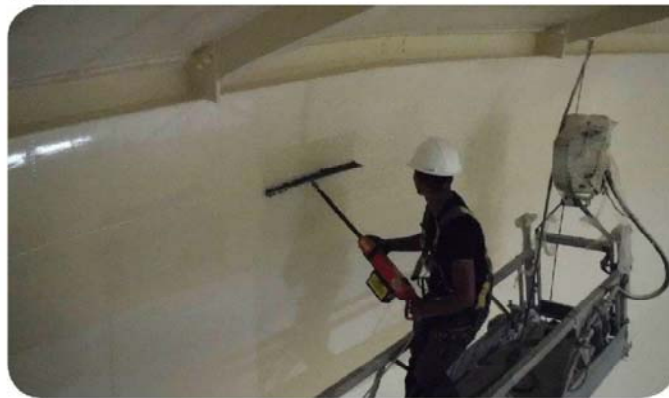
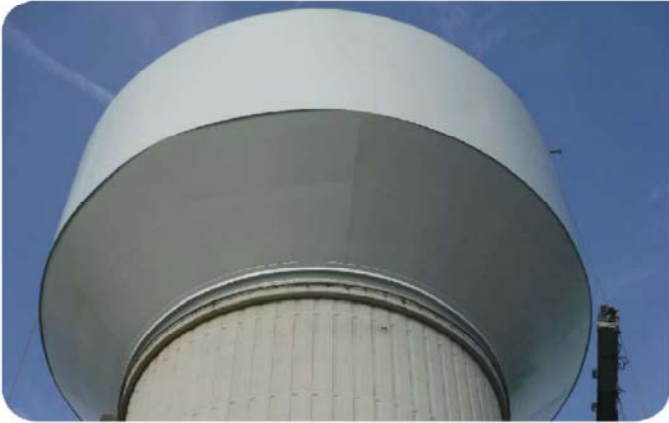
Wet and dry film thicknesses were tested with various gages throughout the project. Also done throughout, the crew members were sure to wear harnesses and lanyards when working from heights.

Despite delays with having welders add the exterior panels and stops throughout the job to avoid heat exhaustion, the Blastco crew got all prep work, coatings, and linings done. Maintenance achieved!

thickness. You can only do so much when you're painting, which is with the wet film, but you have to wait 'til the next day — eight hours minimum — to go in with your DFTs," Winter explained. They used DeFelsko's PosiTector 6000 to confirm the dry film thickness.

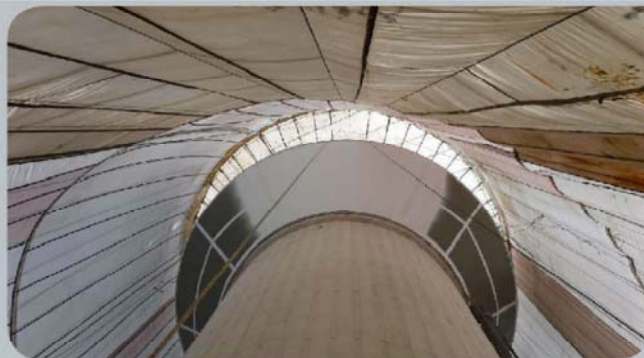
Containments are hung from the bottom up, meaning they're placed around the ground around the tank and then winched up to the top. We used a 6-ton (5,443.1 kg) air-powered winch to do that here.

The winch system was installed by a welding crew, made up of two welders, to complete the task. The system included rigging boots and pulleys. The rigging boots were installed

around the perimeter of the tank. On this project, there were a total of 54 outriggers installed. Then, to build the containment tree, the pulleys were welded around the center of the tank. The pulleys were used to run the cables to the top of the tank to allow the crew to winch the container to the top.
