Jacked Up Tank Job

Steel Tank Job

Apply interior and exterior coating systems to a 10-million-gallon (37.8 L) steel water tank in Austin, Texas

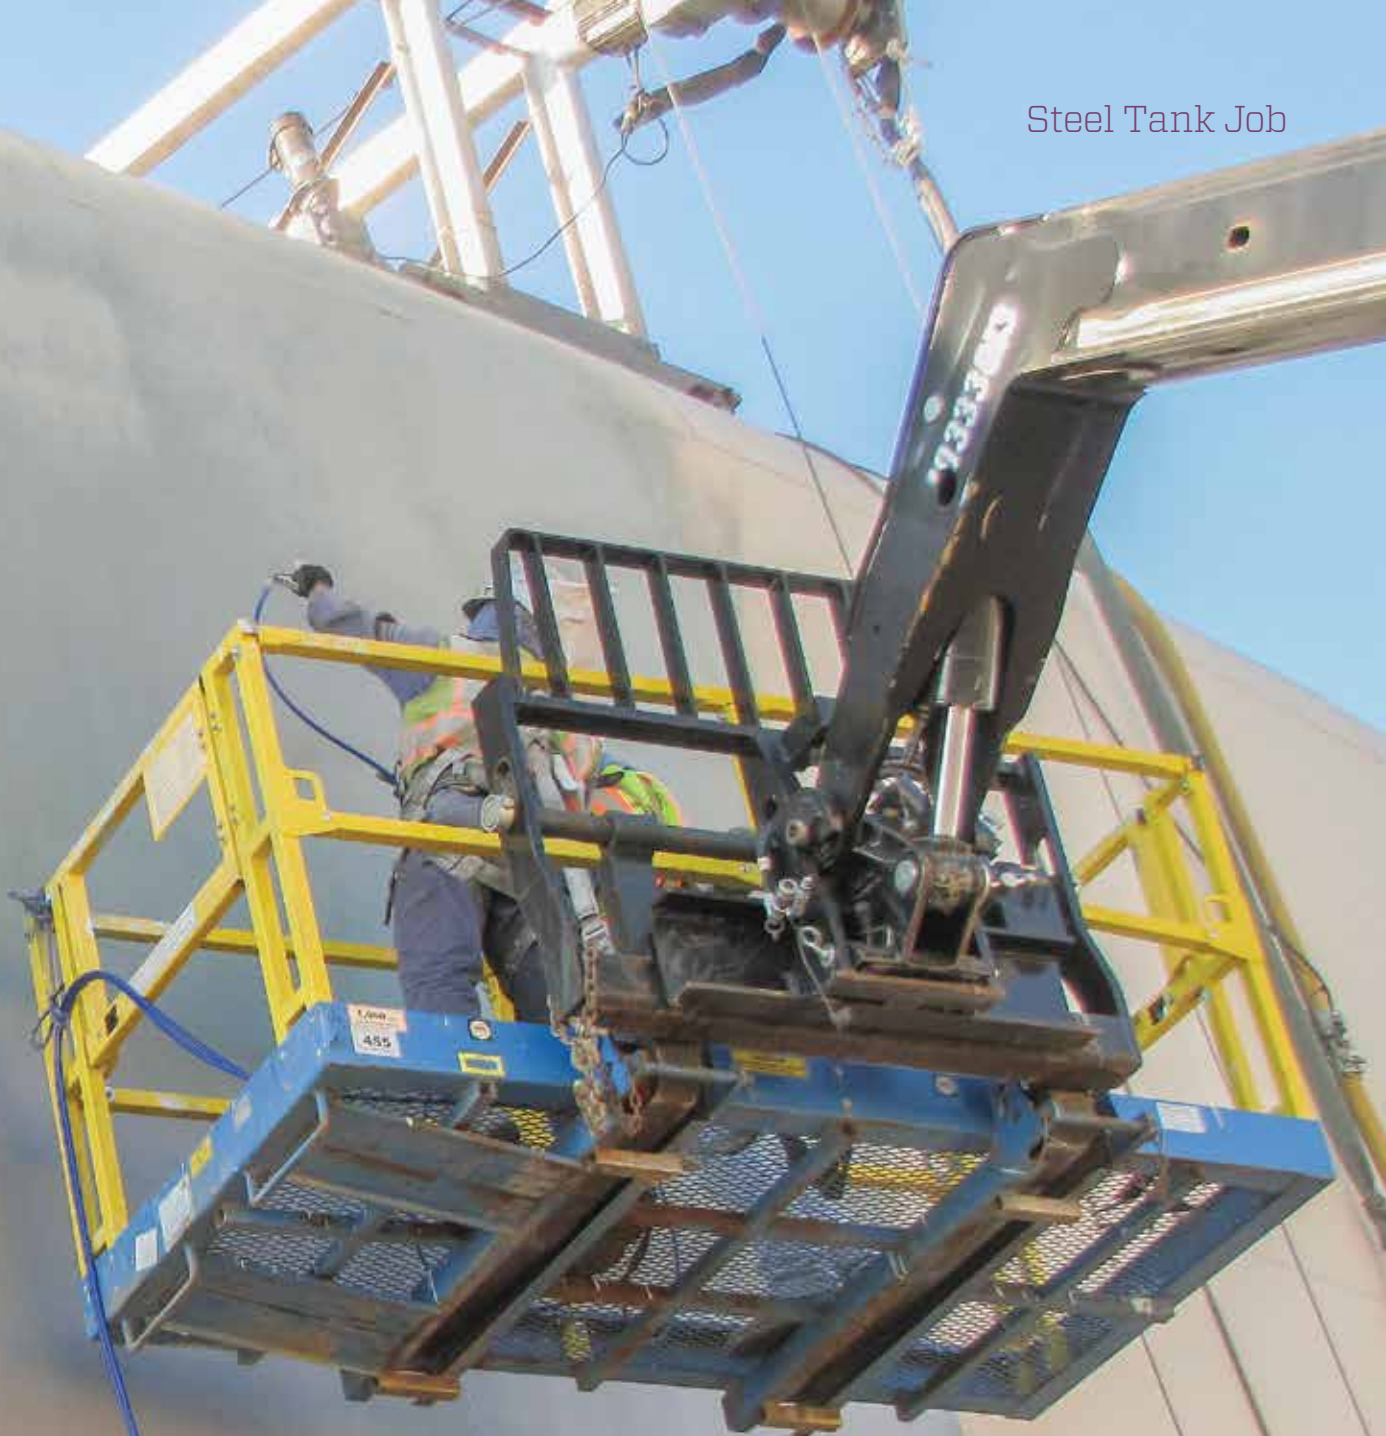
The 231-foot-diameter by 35-foot-tall (70.4 m x 10.7 m) tank — built in 1988, owned by the City of Austin, Texas, and operated by Austin Water — was last coated by Blastco.

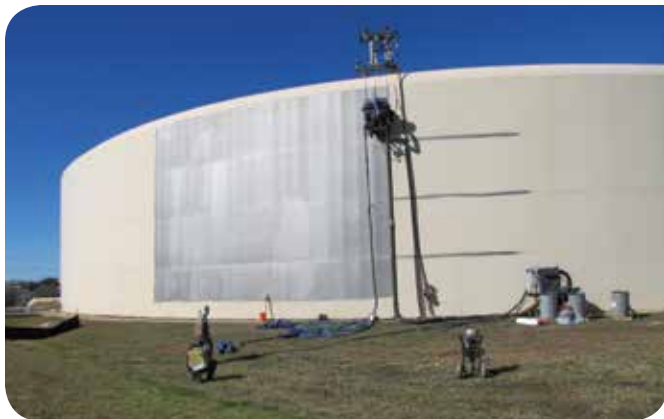
It was up to Blastco, a TF Warren Company, to coat and line a 10-million-gallon (37.8 L) steel water tank in Austin, Texas. They had 160 days to complete the ~205,000 sq.-ft. (19,045.1 m²) job.

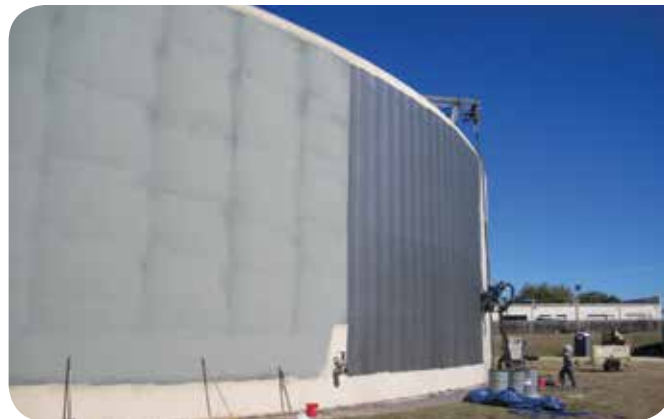
Before coating the steel, they first had to abrasive blast the tank to NACE No. 2/Society for Protective Coatings (SSPC) Surface Preparation (SP) 10: Near-White Blast Cleaning. They used various equipment to do so.

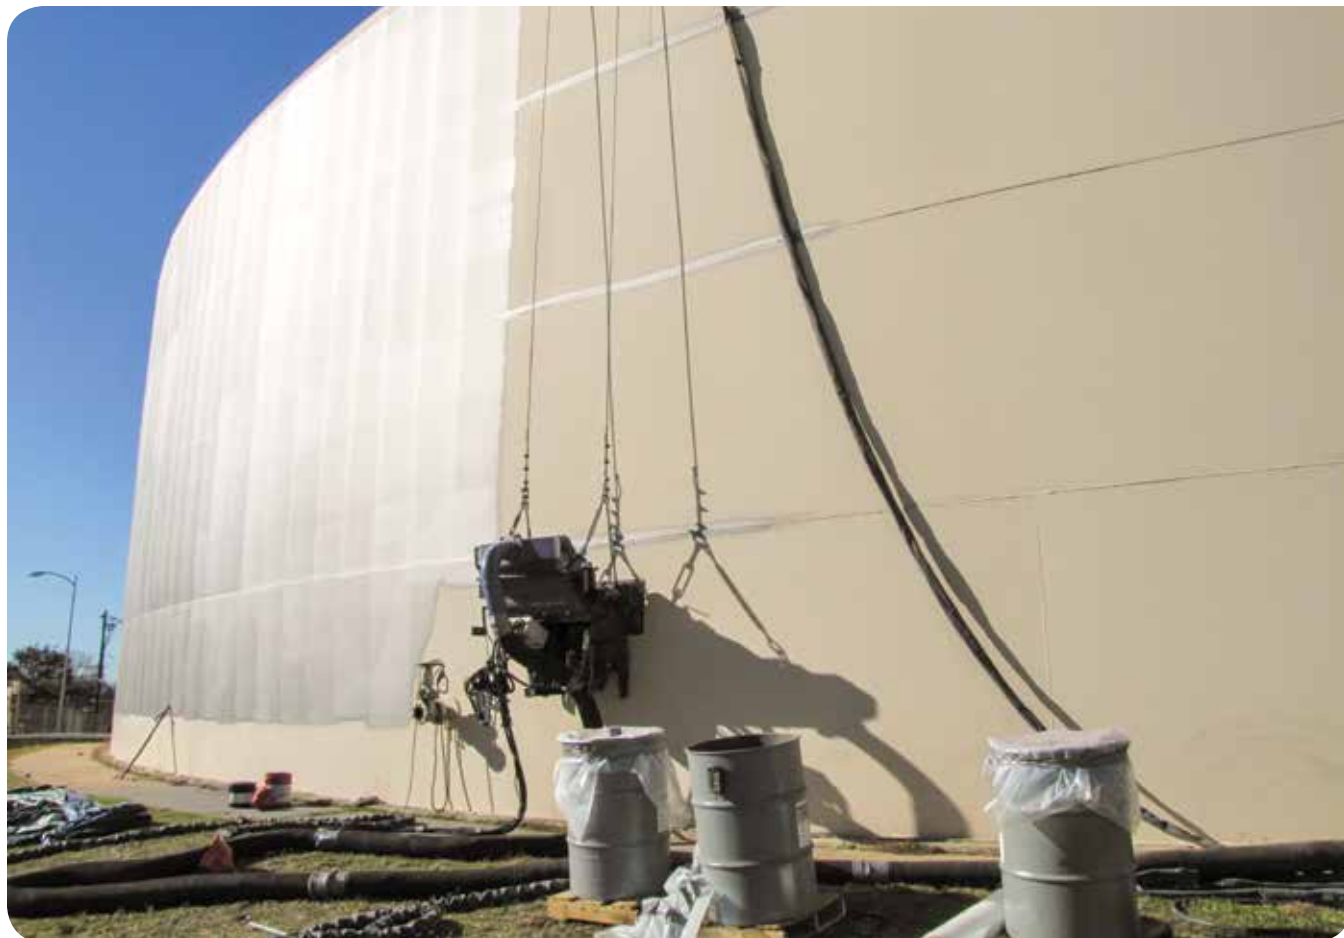
To produce a uniform primer coat, the crew pumped up their Graco airless to approximately 120 psi (827.4 kPa) at the tip, stood back a bit, and sprayed a crosshatch pattern. Overspray was not much of an issue with this primer.

“When Dimetcote hits the tank, it dries so fast it only looks

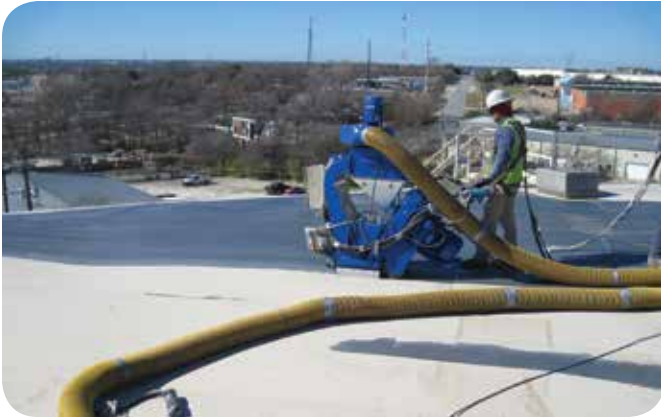
Inside and outside the tank, the 10- to 15-person crew wore fall protection when working on scaffolding, boom lifts, and near the roof perimeter. When blasting, they also wore air-supplied hooded respirators.

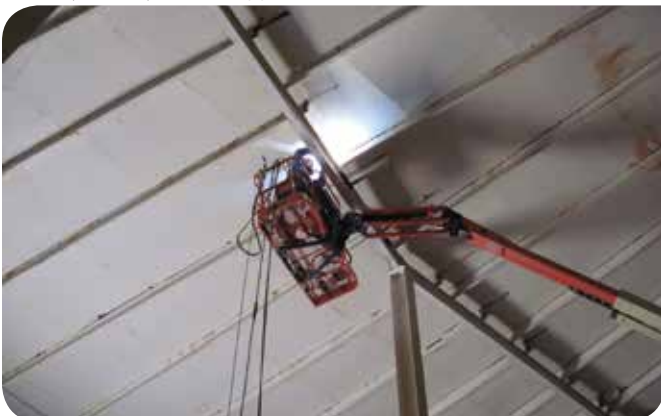
To access areas between the roof plates and the tops of the rafters, the entire 231-foot-diameter (70.4 m) roof had to be lifted approximately 4 inches (10.2 cm) off the support braces.

Using a dozen or so 2-ton (1,814.4 kg) hydraulic jacks, the crew raised the entire 231-foot-diameter (70.4 m) roof just enough to allow them to insert 4-inch by 4-inch (10.2 cm x 10.2 cm) wooden blocks to safely bear the weight. (Apparently, Texas tank designers know better than to weld roofs to rafters and walls.) With rafter tops and the entire ceiling exposed, the crew had just enough access to blast and spray.

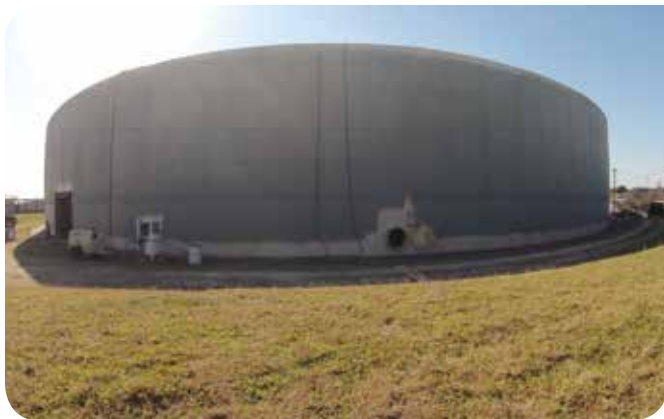
Weather played an important role on this job. First, the project took place during the winter and spring months when the area's water demand was low. Also, the crew had to stop work during thunderstorms.

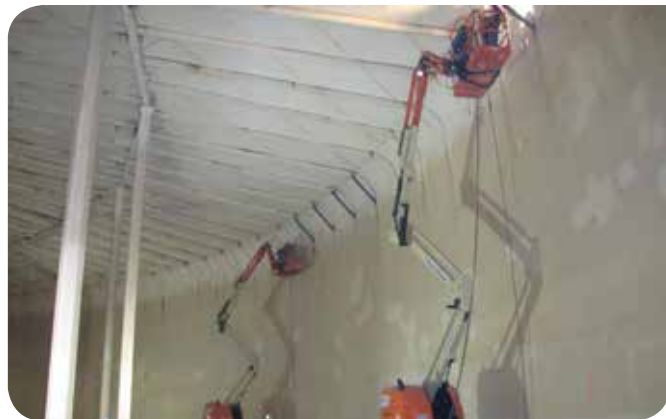
The tank interior was also abrasive blasted to NACE No. 2/SSPC-SP-10: Near-White Blast Cleaning. Then the crew spray applied a coat PPG Amerthane 490 at ~30 mils (762.0 microns) dry film thickness (DFT).

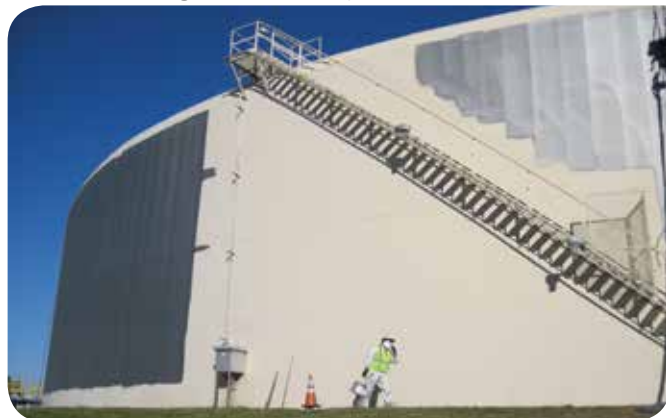
Once the exterior substrate was prepped, the crew could start to coat. The system started with 3–4 mils (76.2–101.6 microns) DFT of Dimetcote 9H inorganic zinc silicate primer.

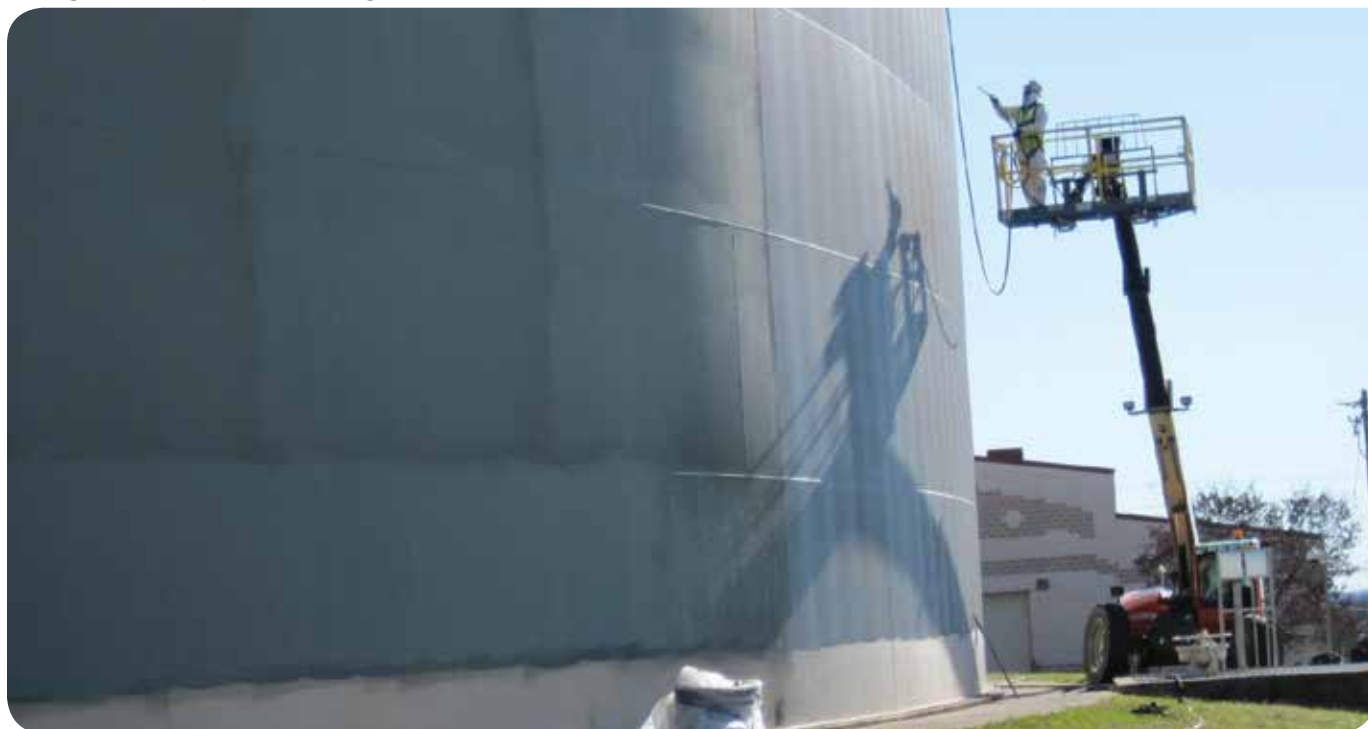
The crew applied 3–8 mils (76.2–203.2 microns) total DFT of Amercoat 385, but had to wait two months between the coats. That meant coming back in and pressure washing in between, too.

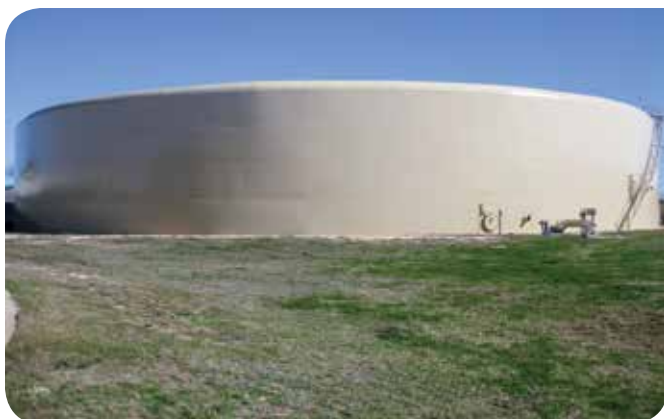
The final layer of coating was 5–7 mils (127.0–177.8 microns) DFT of PSX 700 topcoat, which the crew roll applied. With that, the city of Austin was ready to go!
